STS-27R OV-104 ORBITER TPS DAMAGE REVIEW TEAM

SUMMARY REPORT

VOLUME I

FEBRUARY 1989

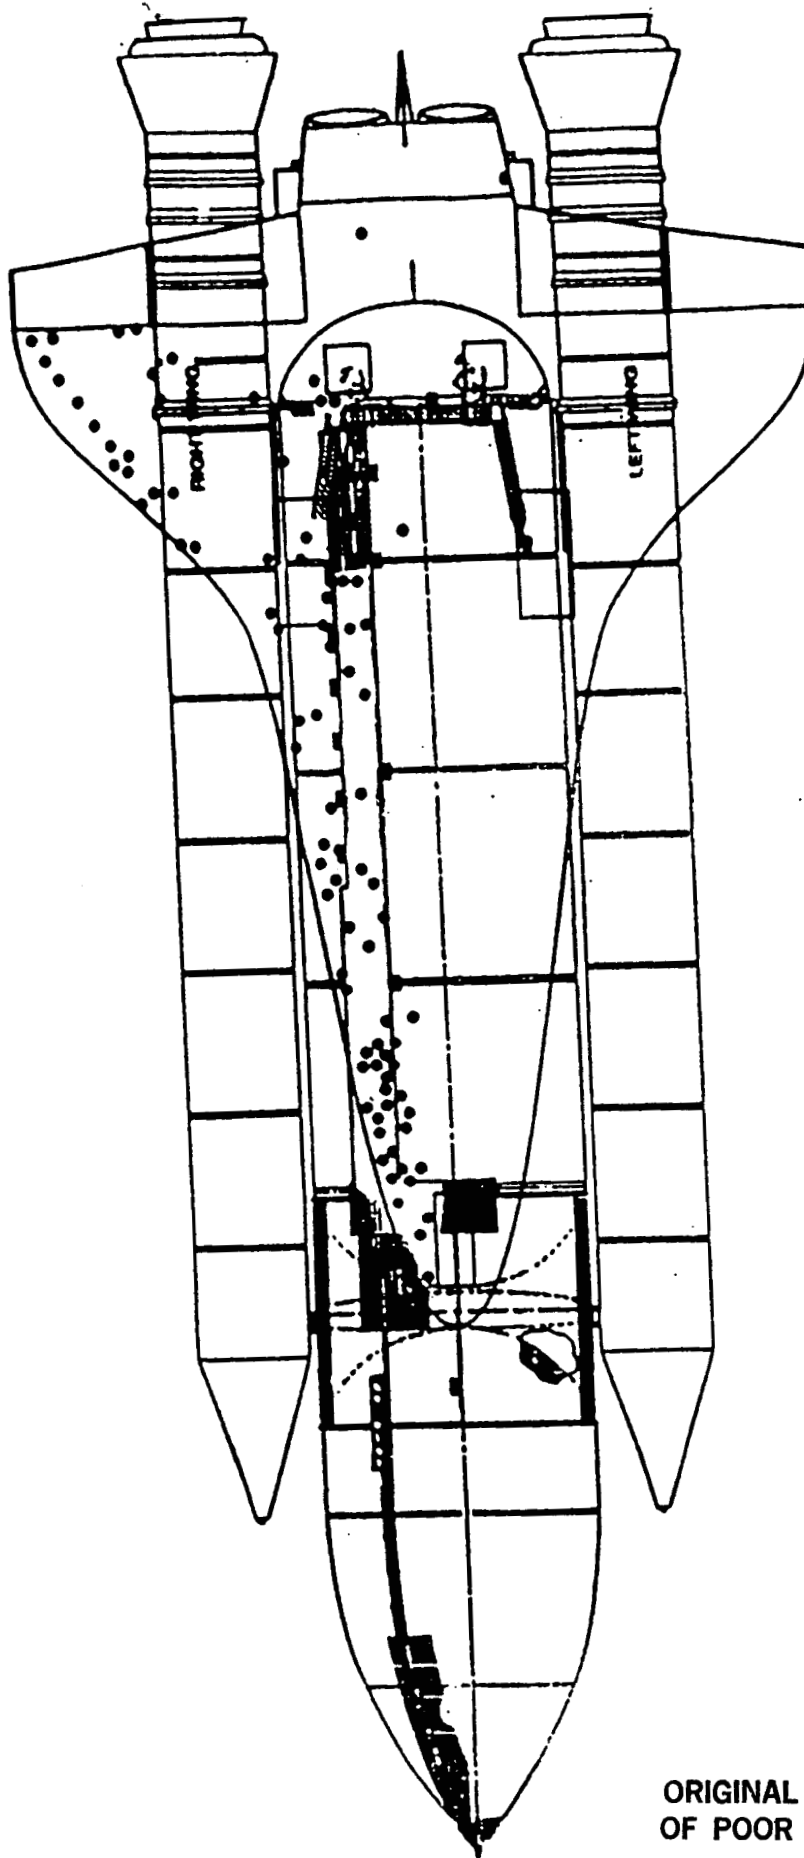
FIGURE 2-9
ET TPS LOCATION/DEFINITION RELATIVE TO ORBITER
LOWER SURFACE TILE DAMAGE PATTERN

The Orbiter damage sites and missing hardware are shown in Figures 2-8 and 2-9 depicting their relationship to the integrated Shuttle vehicle. Also, Figure 2-10 is included to depict the STS-27R major flight parameters.

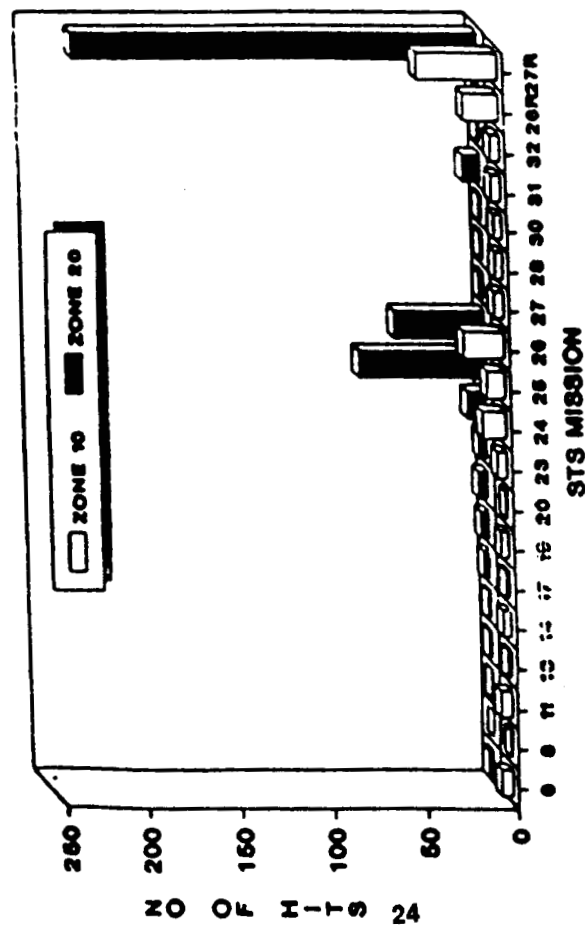
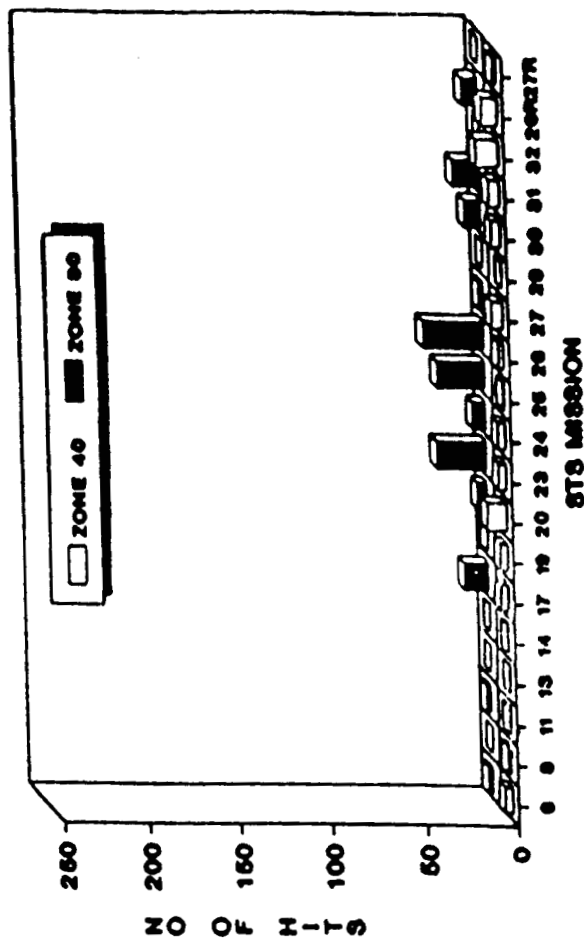
FIGURE 3-3

*NOTE: 372 hits on lower surface not annotated on debris map; all assumed to be on right side.

HISTORICAL ORBITER TPS DAMAGE NO. OF HITS WITH LENGTH ≥ 1 IN

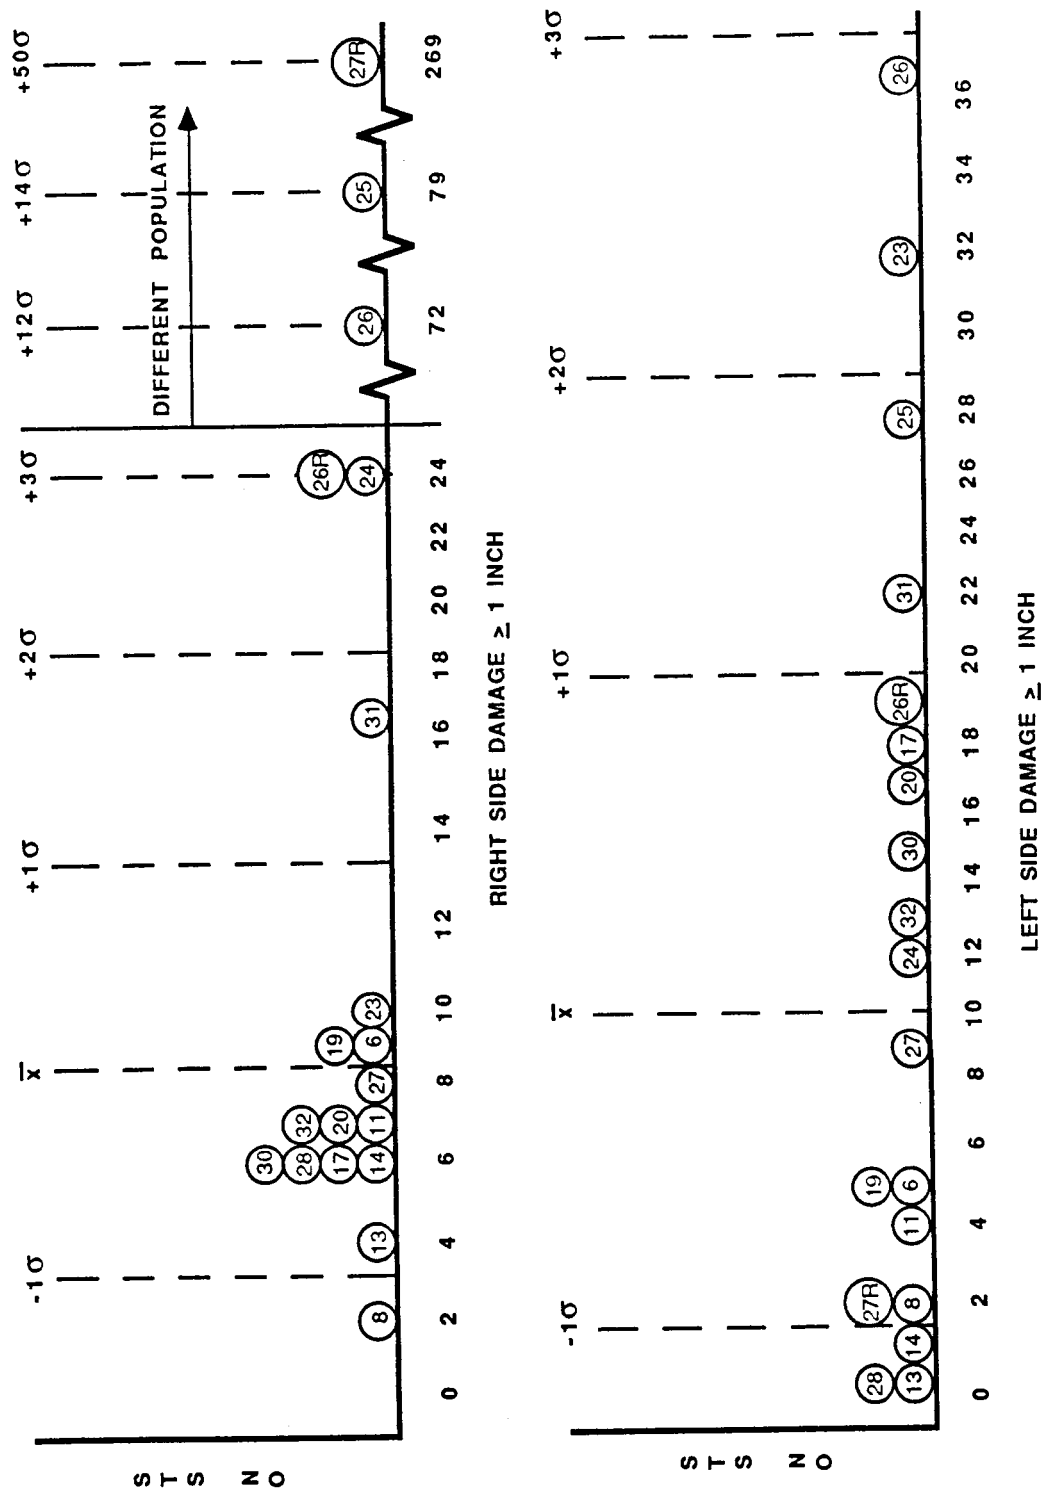
FIGURE 3-5
DATA REVIEW AND CORRELATION
ORBITER TPS DAMAGE REVIEW TEAM
STATISTICAL CORRELATION

The damage data base compiled to correlate previous tile damage, paragraph 3.1 above, was utilized to determine if STS-27R was within the prior damage population extremes. This statistical comparison used the damage attribute where any dimension is greater than one inch and was performed for both the Orbiter left and right sides. (See Figure 3-5.)

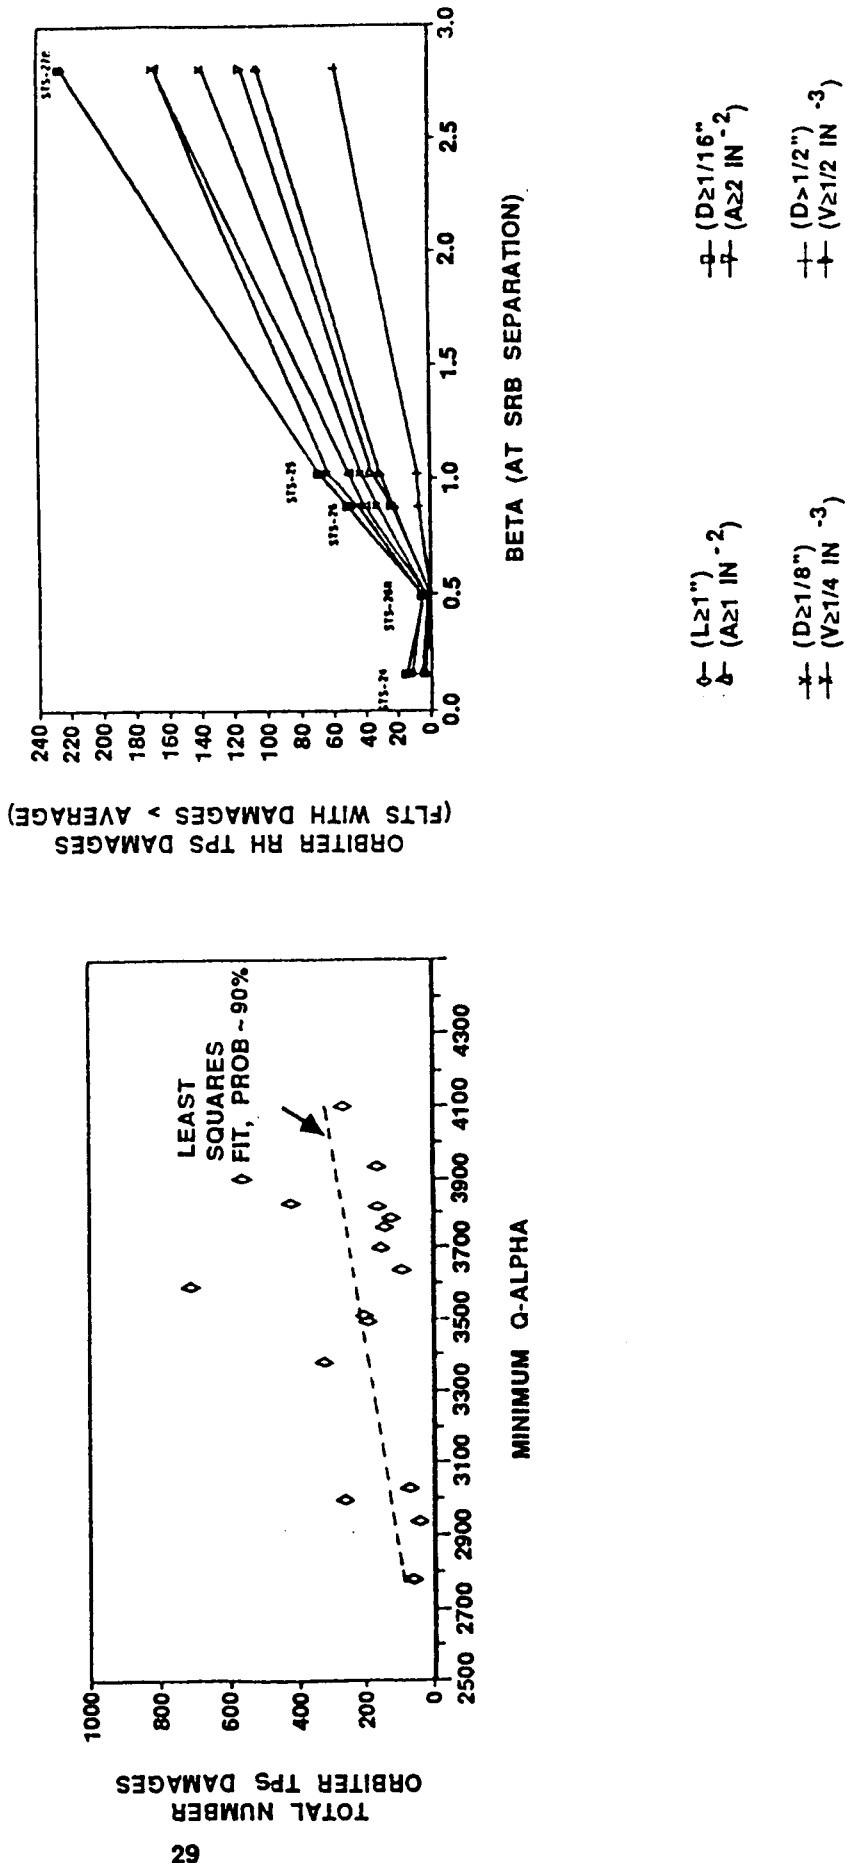
FIGURE 3-6 DATA REVIEW AND CORRELATION ORBITER TPS DAMAGE REVIEW TEAM FLIGHT DATA CORRELATIONS STS-27R

The total parameters compared with prior flights are shown in Table 3-1 and the data tables, and plots are contained in Volume II of this report. The comparison revealed only a slight right side total damage site correlation with minimum Q Alpha, and some correlation between large tile damage sites and Beta at SRB separation. (See Figure 3-6.) Even though there appears to be a slight correlation between total damage sites and minimum Q Alpha, the same is not true for large damage sites. It is

therefore concluded that Q Alpha was not a potential cause for the STS-27R severe damage. It is further concluded that Beta was not related to the severe damage cause because it was well within design limits, and that if debris had been generated in the SRB separation flight regime, analysis shows that it could not have damaged the tiles.

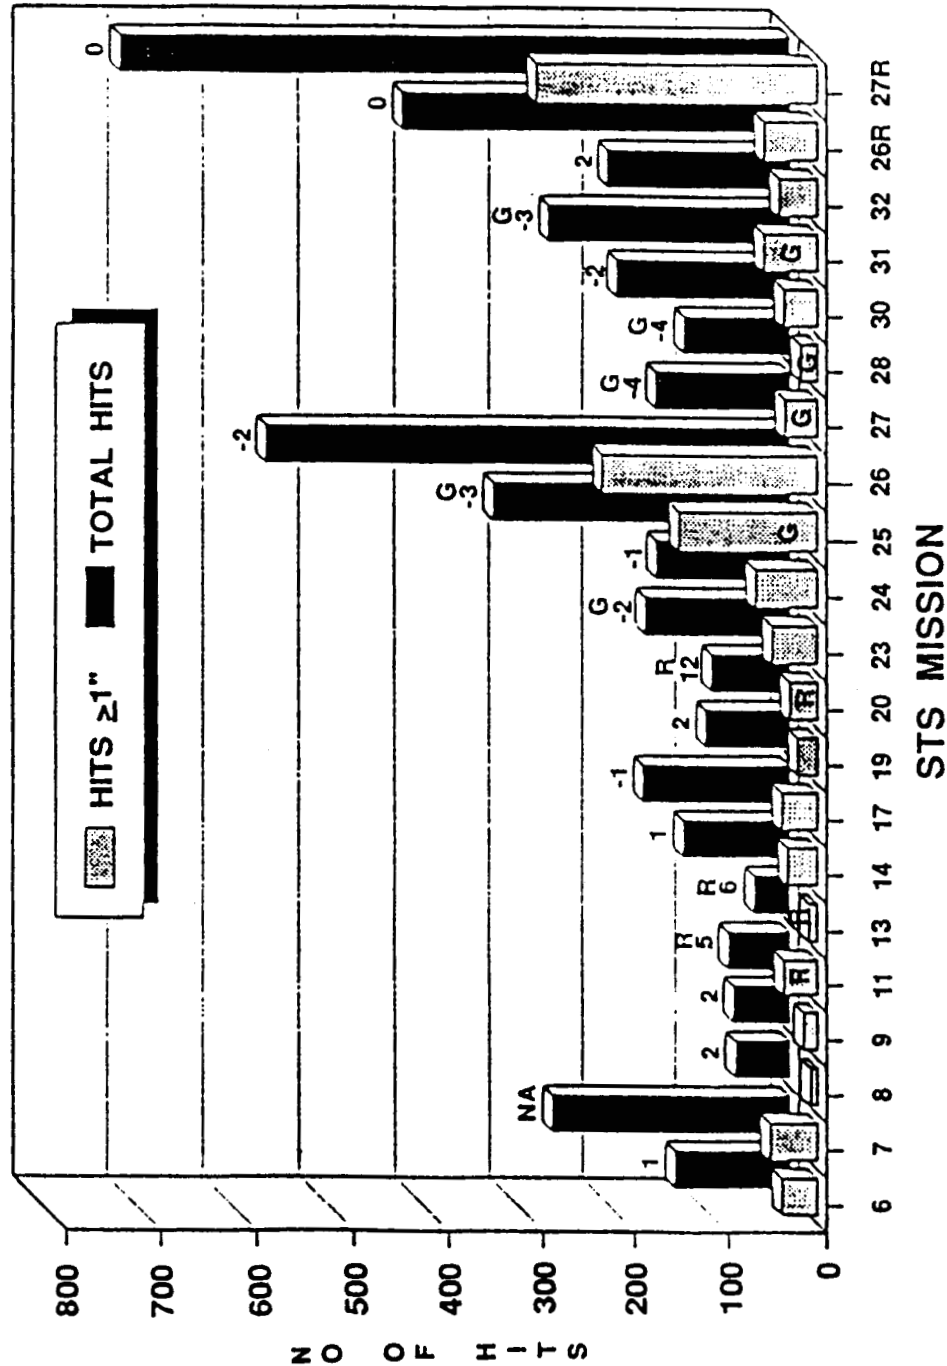
TOTAL HITS AND HITS $\geq 1"$
AND ICE FIGURE OF MERIT (SHOWN ON TOP OF BLOCKS)

NOTE: FIGURE OF MERIT IS RELATIVE
ORDER OF ICE FORMATION ON ET
AT APPROX. T-3 HOURS. ALL NUMBERS
ARE RELATIVE TO STS-27R.

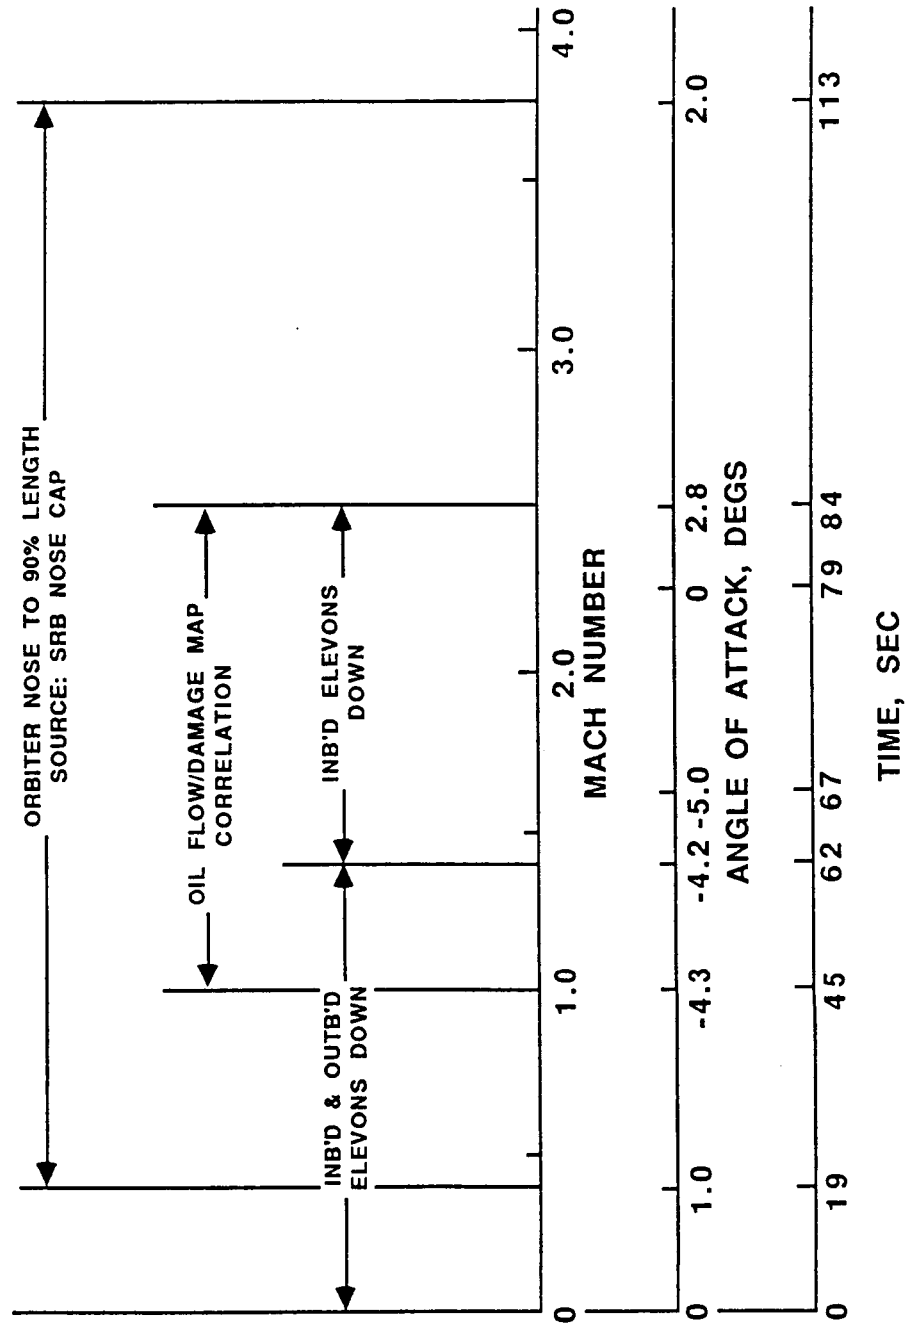
FIGURE 5-2
 ORBITER TPS DAMAGE REVIEW TEAM
 ASCENT DEBRIS TRAJECTORY SIMULATION

Figure 5-2 graphically depicts the assessment results leading to the most probable flight regime. Based on debris energy calculations versus tile damage energy thresholds, it was established that SRB Nose Cap debris can damage the Orbiter between Mach 0.4 and 3.75, and for ET Nose Cap debris between Mach 0.4 and 2.5. It is also shown that between Mach 1.0 and 2.5, the STS oil flow results correlate well with the Orbiter damage pattern. Further, it reflects that the Orbiter inboard elevon moves to neutral (i.e., out of the direct flowfield) at Mach 2.5. Therefore, since elevon damage history (Figure 5-3) shows damage on all flights prior to STS-27R, it is apparent that the STS-27R damaging debris event occurred after Mach 2.5.

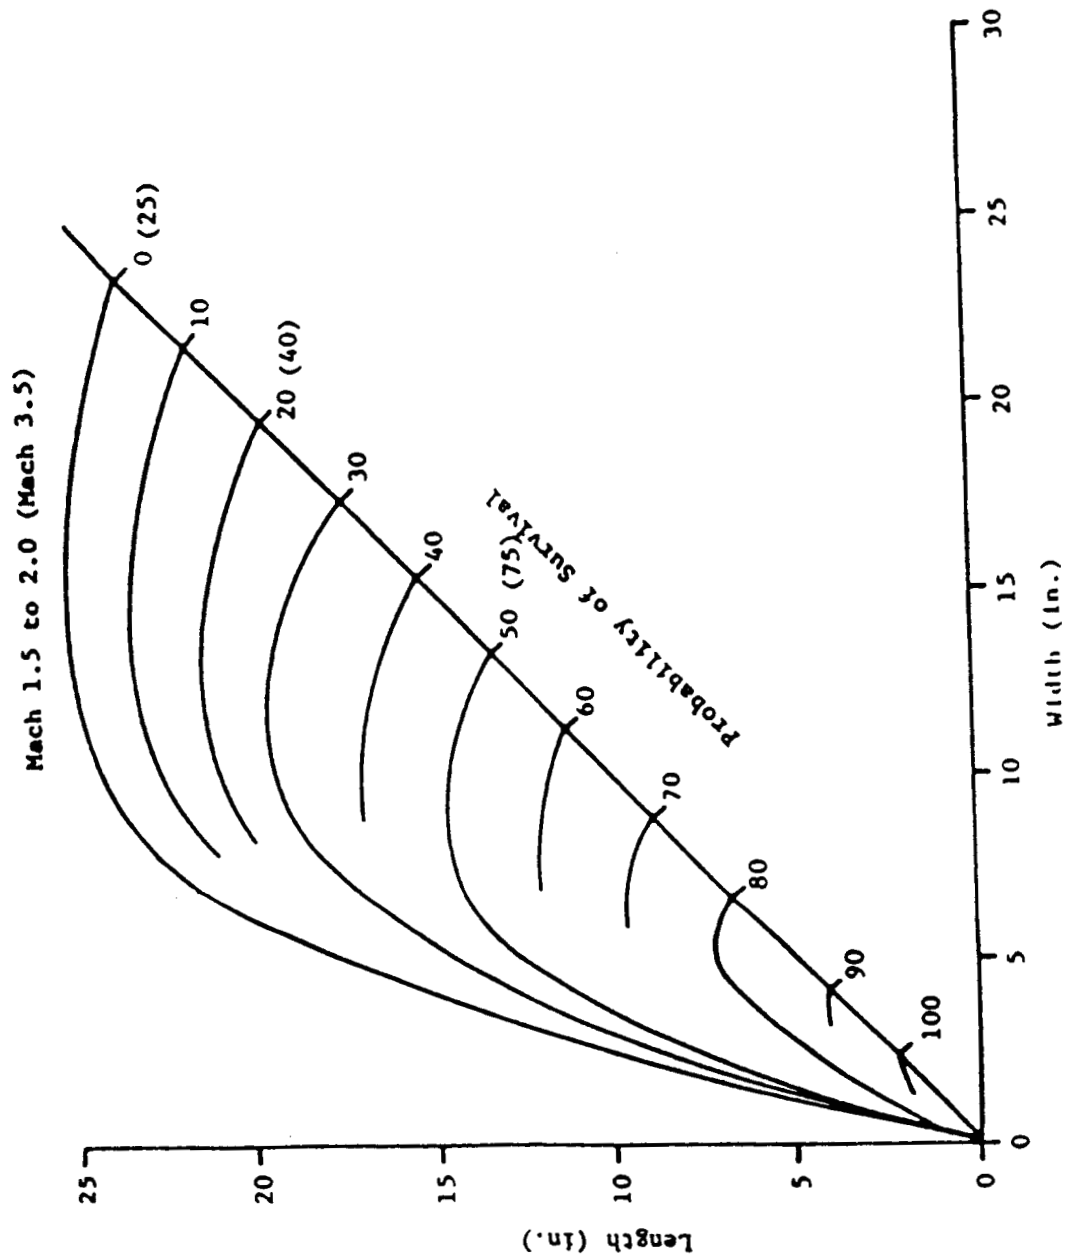
FIGURE 5-4
 ESTIMATED PROBABILITY OF MSA-1 DEBRIS SURVIVAL
 THROUGH ORBITER NOSE SHOCK

Debris passing through the shock wave is exposed to the two separate forces, which produce uneven loading or moments about the debris center of gravity (CG). Bending moments about the debris CG were calculated using a distributed lump mass approach. If the bending stresses were greater than 50 percent of the allowable MSA-1 tensile strength, a failure was assumed. The survival of each debris size for a given orientation was calculated using the methodology described above. The survival probability was calculated for each debris size as a function of pitch (0-90°) and roll (0-90°) combinations. Figure 5-4 presents the debris survival probability results versus debris planform size. It is noted from these data that a piece of MSA-1 .25 x 5 x 10 inches has a 70 percent probability of surviving transition through the Orbiter nose shock. Therefore, it is considered reasonable that this size debris could move from the SRB nose area to the Orbiter damage site without losing its structural integrity.

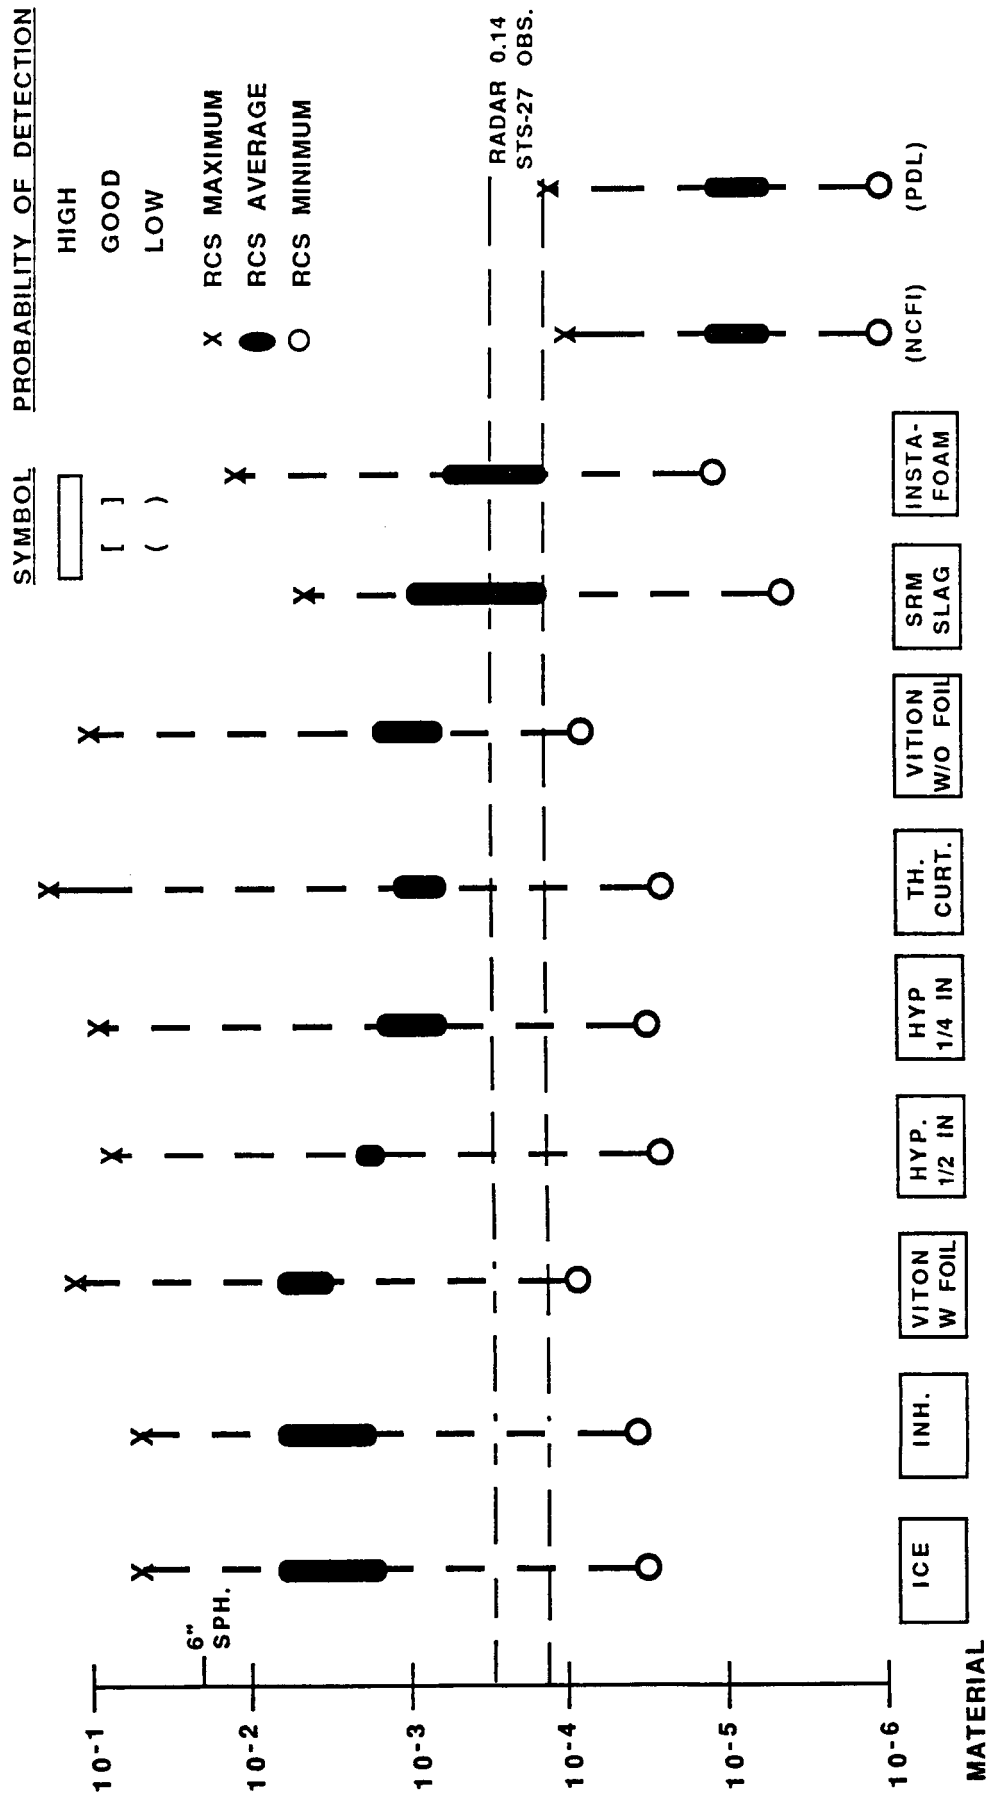
FIGURE 5-5 ORBITER TPS DAMAGE REVIEW TEAM C-BAND RADAR MATERIALS RELECTIVITY TEST

Table 5-3 lists the STS debris samples, their sources, and sizes provided for C-band characterization. Figure 5-5 presents signal strength characterization for 20 of the noted samples overlaid with the C-band Radar signal strength range for the STS-27R observed objects. The various debris types have been annotated to present a qualitative probability-of-detection (high, good, low). It was determined that four of the 20 samples tested, at the size tested, could not have been the STS-27R objects. Any of the remaining samples could potentially have been the source. Closer discrimination could not be made because the object signal returns were so faint.

The overall C-band observations significance was established, based primarily on the conclusions reached in Section 5.2, Debris Trajectory Analysis/Damage Flight Regime. Because the potential for damaging the Orbiter tiles by the suspected SRB or ET debris sources diminishes rapidly beyond the Mach 3.8 timeframe (Figure 5-2), it is not likely that the several unidentified C-band objects which were observed subsequent to SRB separation (T + 141 to 169 seconds) contributed to the STS-27R Orbiter tile damage. Although the single object observed at T + 53.5 seconds is in flight regime of potential damage, it is not consistent with the Mach 2.5 most probable flight regime, in particular, the no-elevon-damage consideration.
